OLD PARLIAMENT HOUSE

Canberra ACT, Australia

PROJECT REFERENCE - SYSTEM ARDEX

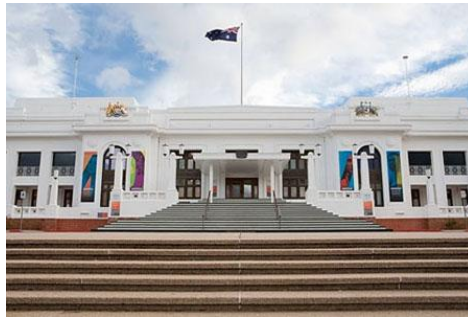
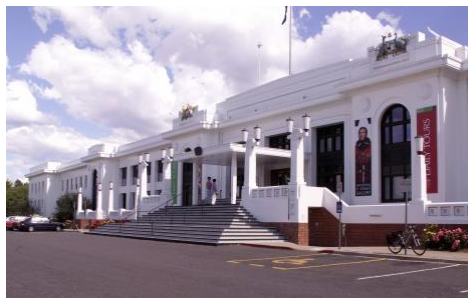
It was discovered during the excavation that the main entry stairs leaked severely causing minor flooding.

Following removal of the existing tiles and multiple applications of various membranes, Ardex **LQ 92** was used to re-establish correct falls, followed by two applications of Ardex **WPM 300** and two applications of Ardex **WPM 002** waterproof membrane. Tiles were directly applied to the membrane with Ardex **Optima** tile adhesive and grouted with Ardex **FG 8**.
